## Property Inspection Report

**Report Number: 20230301JF1**

123 Main St.  
Raleigh, North Carolina 27604

**Date of Inspection: Wednesday, March 1, 2023**

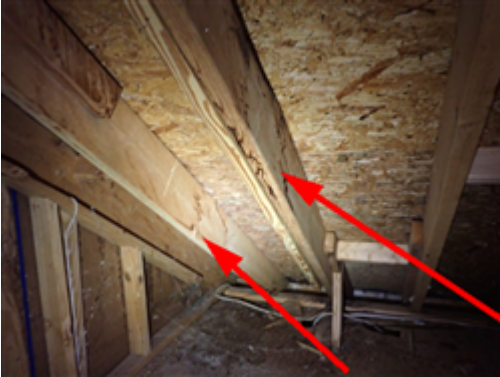
#### **(A6 - 1.1 ) Main House**

In the attic, the roof sheathing above the living room and dinning room had areas of discoloration that appeared to be the result of roof leakage. Moisture meter testing showed no elevated moisture levels in affected areas at the time of the inspection. Either the source of the leak has been corrected, or the lack of recent rain may has allowed sufficient time for the sheathing to dry. Owner disclosure is recommended and/or invasive inspection by a licensed roofing contractor to ensure the weathertightness of the roof shingles.

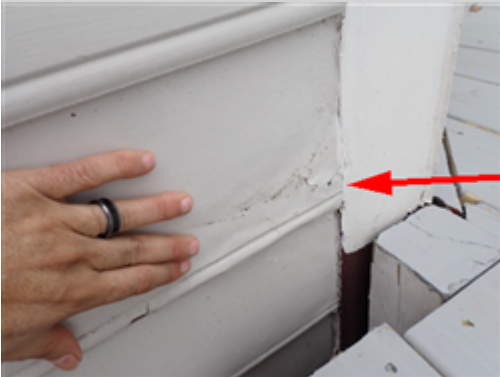
This home has Hardboard Siding. Many homes built between 1970 and the 1990's were sided with this composite type siding. Over the years there have been class actions lawsuits related to claims of improperly manufactured siding and problems with decay. The problems were accelerated due to the limited life expectancy of this siding material; most products were warrantied only for 20 to 25 years. Hardboard siding naturally absorbs water when not protected and improper maintenance can result in siding decay and hidden damage. With proper sealant application and regular paint maintenance, this process can be controlled and kept at a safe level for many homes. However, improperly manufactured, maintained, and or installed hardboard siding can undergo serious deterioration that can result in the need to replace the siding as well require repairs to the underlying structure. The siding for this home was found to be in fair condition. Siding boards were noted to have swollen edges, swollen nail spots, and decay in adjacent trim pieces around the perimeter of the home. The visible exterior decay could also indicate damage to the substrate and underlying framing. A licensed general contractor should be consulted for a complete evaluation to determine the extent of the damage to the siding, trim, and underlying components and to make necessary repairs.

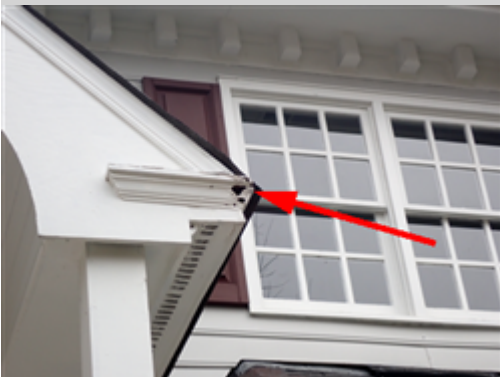
The wood trim pieces for the siding system are decayed at several corner locations. The corner trim provides a finished edge for siding and protects the underlying sheathing. Decay of the corner trim can allow water to enter behind the siding and result in damage to the framing. A licensed general contractor should be consulted for an invasive inspection to determine the extent of the damage to underlying components and make necessary repairs to ensure the weathertightness of the cladding system.

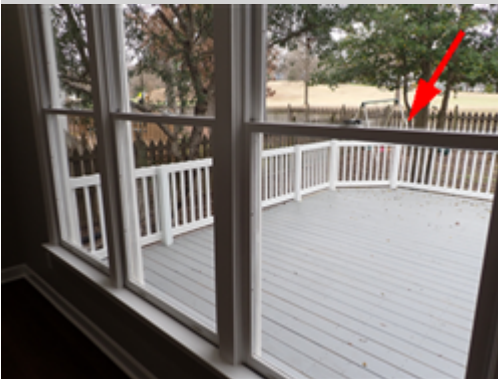
A rear living room window will not remain in the open position and may drop suddenly when opened. Repair is needed to ensure proper function of the window. A licensed general contractor should be consulted for evaluation and repair.

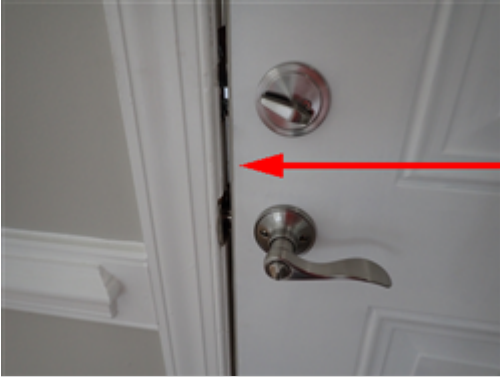
The front entry door reveals daylight at the door frame when latched. This can cause some heat loss in the winter and loss of cool air in the summer if not corrected. A qualified person should repair or replace as needed.

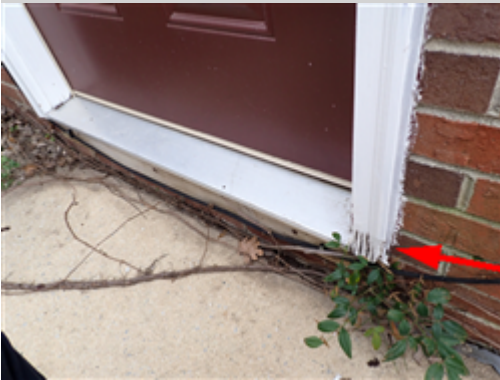
The left exterior door (Garage area) has soft and decayed wood in the frame area. Decay in the door frames can result in leaking and water penetration and should be repaired as soon as possible. A general repair specialist or licensed general contractor should be consulted for evaluation and repair.

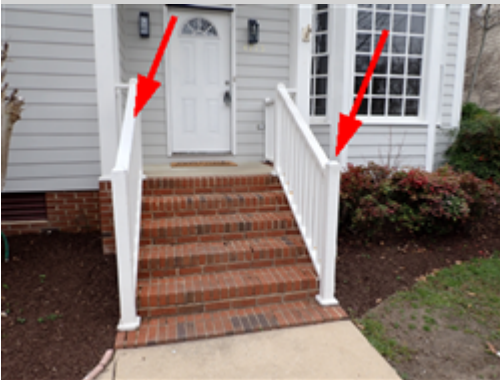
The guardrails to the front porch steps were loose and present a safety/fall hazard. Repair is needed to prevent further damage. A licensed general contractor should be consulted for evaluation of the deck handrail system and to make necessary repairs.

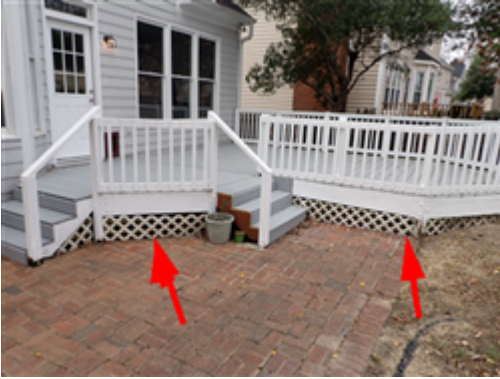
The area under the rear deck was not accessible for inspection. Its recommended to create an access point and have the area properly inspected prior to closing to ensure safe use of the deck area.

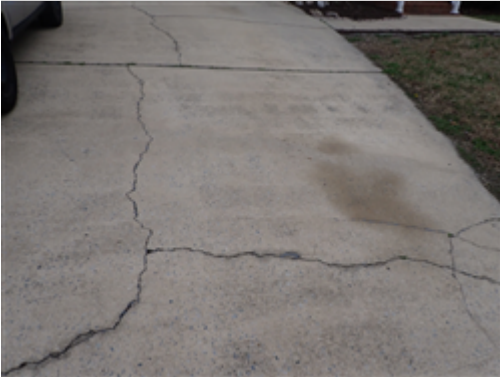
The driveway is cracked and displaced. The raised section of the driveway has created a path for water penetration under the slab and a trip or fall hazard. A licensed general contractor should be consulted for further evaluation and repair.

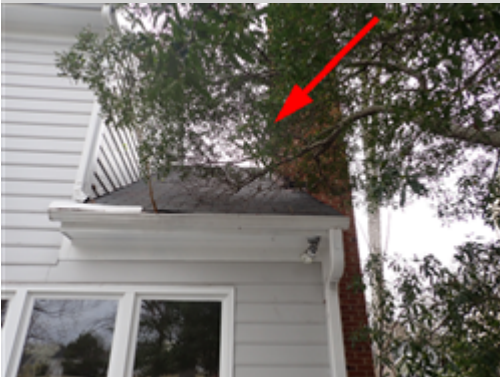
Tree limbs may decrease the life-span of siding and roof material. The tree limbs that are in contact with/near the roof and eaves areas around the home should be trimmed. A qualified person should be consulted for evaluation and repair.

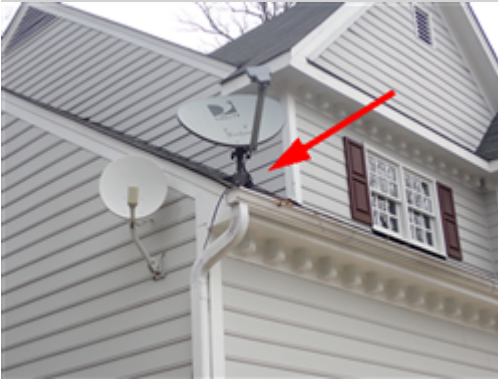
Installation of TV satellite receivers is not recommended on the roof. The installation requires for the roof shingles to be damaged. Further evaluation is needed to determine the significance of this concern. A licensed roofing contractor should be consulted for evaluation and repair as needed to ensure the weathertightness of the roof.

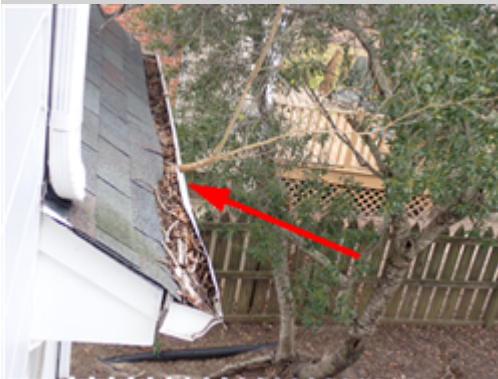
The gutters were full of debris in some areas, and need to be cleaned. Debris in gutters can conceal rust, deterioration, or leaks that are not visible until cleaned, and I am unable to determine if such conditions exist.

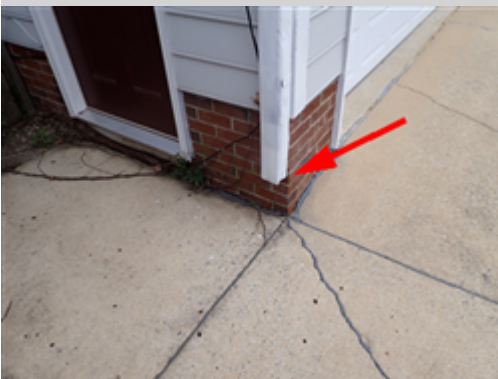
The front left downspout needs an extension to carry water away from the foundation of the home. The current configuration has the downspouts draining into the foundation of the home. A licensed, general contractor should be consulted for evaluation and repair.

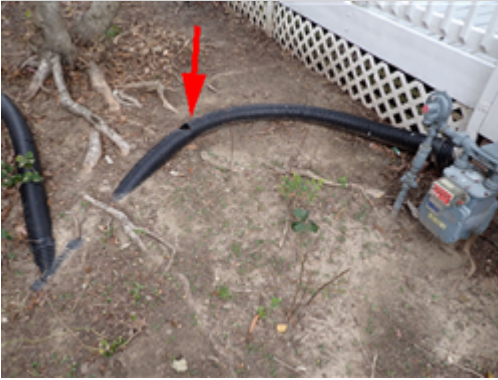
Several gutter downspouts were piped underground and had visible damaged . Some of the downspouts exits were not located or verified. Evidence in the bedding area and at the roof eave level suggests that the gutters have been overflowing. Direct drainage to the foundation and cladding from the gutter system can result in water penetration into the foundation area and foundation deterioration. A licensed general contractor should be consulted for a complete evaluation to locate and verify the downspout extension and to make necessary repairs.

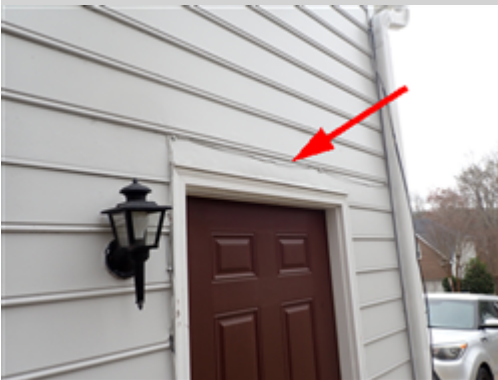
At the time of the inspection, the exterior windows and doors appeared to have no flashing installed above the opening and were dependent upon sealant to prevent moisture intrusion. Because sealants will eventually dry, shrink and crack, leaving the home exposed to possible moisture intrusion, sealant-dependent areas should be examined on an annual basis and sealant re-applied as necessary. Further evaluation is needed to determine the significance of this concern. A licensed general contractor should be consulted for evaluation and repair as needed to ensure the weathertightness of the cladding system.

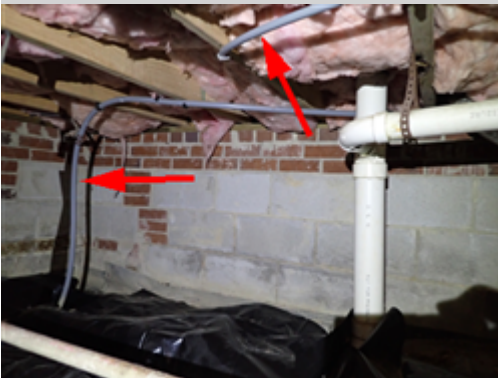
This home has a plumbing supply system that uses polybutylene plastic distribution lines and compression band fittings. Even though this plumbing system was installed in many homes from 1978 until mid-1990's, it is no longer manufactured in the original formulation as an approved plumbing system due to a history of material failures. The failures were related to improper installation, improper handling, improper storage, and plastic deterioration due to chemical reactions with the water supply. Due to the nature of this latent defect, it was not possible to adequately assess the condition of the plumbing system during the home inspection. A licensed plumbing contractor should be consulted for a complete evaluation of the plumbing system to determine the significance of this concern.

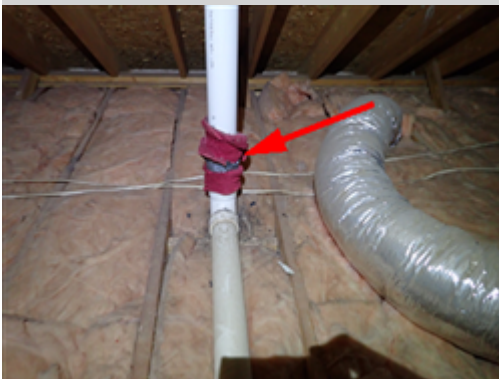
A main vent for the plumbing system has been repaired in the attic. The repair does not comply with typical contractor repair. The upper section of the pipe acts as a vent for waste gases, the lower section of the pipe that carries waste water to the main system. If the main pipe is not installed properly the sewer gases can enter the home or water intrusion, from rain, may happen. A licensed plumbing contractor should be consulted for a complete evaluation to determine the significance of this concern and to make necessary repairs.

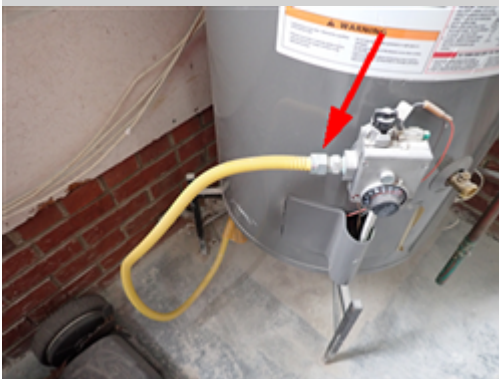
The gas line for the water heater was not installed with a sediment trap in the line to prevent debris from entering the gas valve. This creates a safety issue that could result in personal injury or property damage if not corrected. A HVAC or plumbing contractor should be consulted for further evaluation and repair.

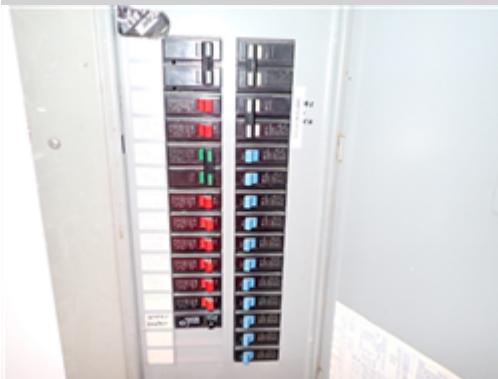
The service breakers in the panel are not properly identified or labeled. Proper labeling ensures adequate service for appliances and sub-panels and the overall safety of system when emergencies occur or repairs are needed. Without proper labels the inspector's ability to evaluate and inspect the system is greatly reduced. A licensed electrical contractor should be consulted for a complete evaluation to label all electrical panels, subpanels, and service breakers and verify the compatibility of the configuration, and the main service disconnect.

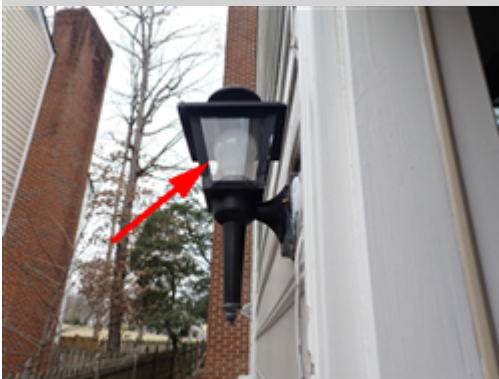
The left exterior light fixture was not functional when tested. This could indicate a defective bulb or other more serious problem such as faulty wiring or a defective fixture. A licensed electrical contractor should be consulted for further evaluation and repair.

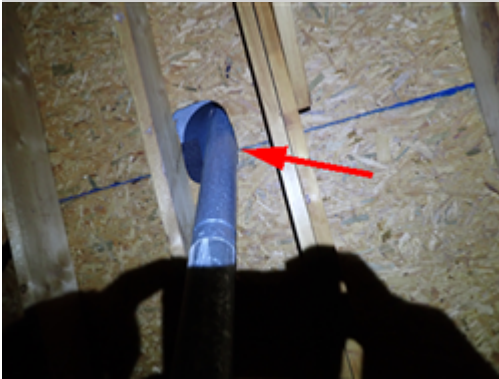
The attic furnace flue was in contact with the wood roof sheathing. Per installation instructions the flue should have a one inch clearance from combustible. This condition creates a fire hazard in need of repair as soon as possible. A licensed HVAC contractor should be consulted for further evaluation and repair as needed to ensure safe and reliable service of the HVAC unit.

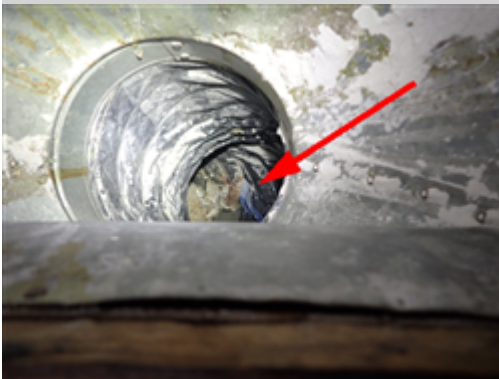
Debris was noted inside the ducts. Debris can reduce air flow and contaminate the air supply. An HVAC contractor should be consulted for a complete evaluation to ensure reliable and proper operation of the HVAC system.

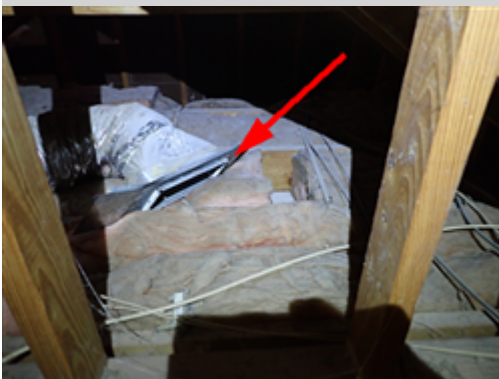
An attic duct above the second floor hallway bathroom was disconnected and in need of repair/replacement. An HVAC contractor should be consulted for a complete evaluation and repair of the duct system to ensure reliable and proper operation of the HVAC system.

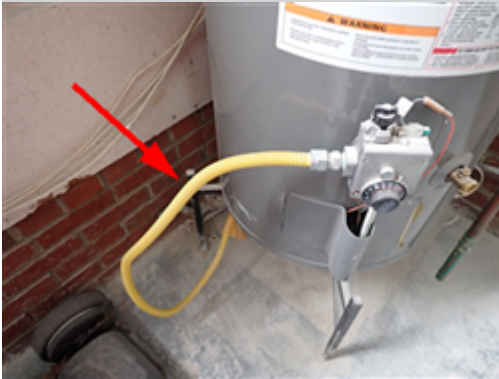
This home has corrugated stainless steel gas lines. This gas line has specific installation requirements related to required bending allowances, support, protection, and electrical bonding to ensure safe conditions. The electrical bonding is typically required to prevent damage from electrical storms in the event of a lightning strike. During the home inspection the bonding attachment could not be located. An electrical contractor should be consulted for a complete evaluation of the CSST installation and to verify the presence of electrical bonding.

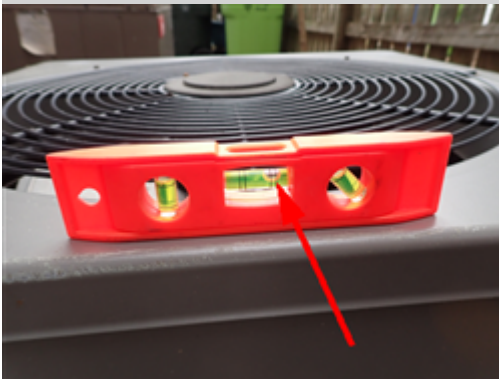
The outside compressor/coil unit for the AC system is not level. The system should be level to ensure proper and reliable operation of the system. A HVAC contractor should be consulted for a complete evaluation and repair of the system to ensure reliable and proper operation of the HVAC system.

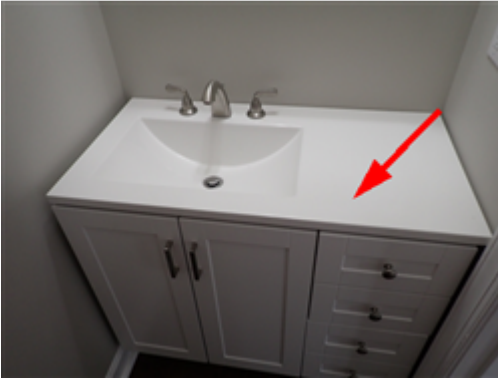
The first floor half bathroom sink counter top was loose. repair is needed to prevent further damage. A licensed general contractor should be consulted for evaluation and repair as needed.

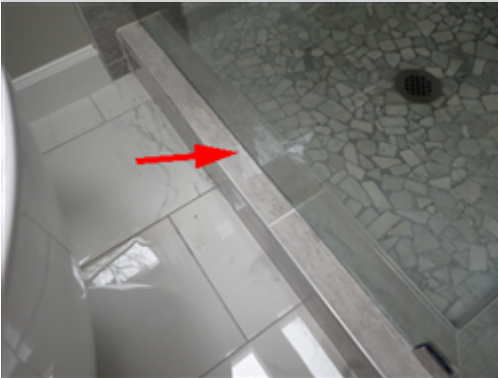
The master bathroom shower wall was missing caulking at the bottom of the wall where it meets the floor. The area leaks when the shower is in use. Repair is needed to ensure proper operation of the shower. A licensed general contractor should repair as needed.

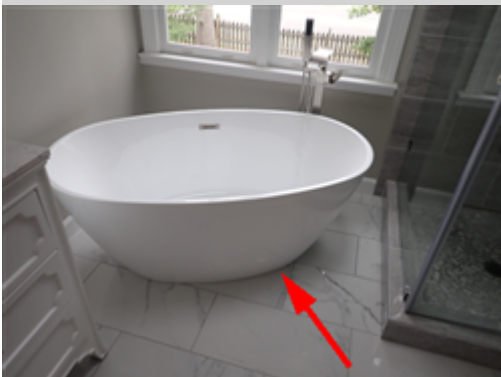
The master bathroom tub was loose. Repair is needed to prevent further damage. A licensed general contractor should repair as needed to ensure proper operation of the tub.

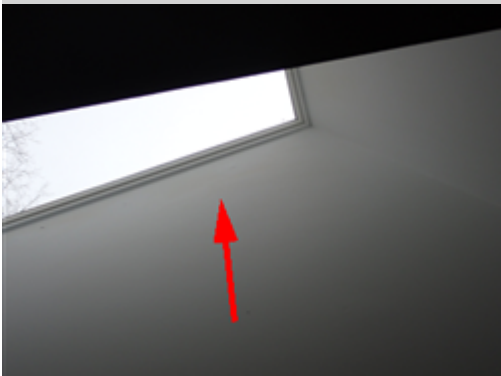
Skylights have a high probability of leaking due to high drainage exposure at their intersection with the roof line and need to be inspected and maintained annually. At the time of the inspection stains were noticed around the master bathroom skylight area. A licensed roofing contractor should be consulted to evaluate the installation, and flashing of the skylight.

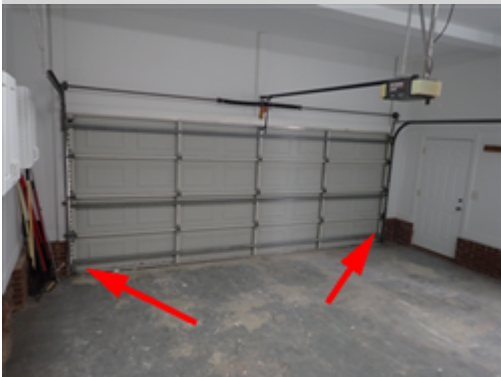
The garage door needs adjustment and repair. The electronic eyes were not present at the time of the inspection. A garage door installation company or a licensed general contractor should be consulted for evaluation and repair to ensure that the door operates safely and properly.

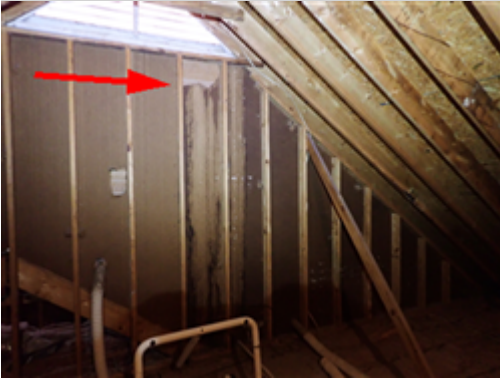
In the attic, the interior wall had areas of discoloration and damage that appeared to be the result of water intrusion under the left gable vent area. Moisture meter testing showed no elevated moisture levels in affected areas at the time of the inspection. Either the source of the leak has been corrected, or the lack of recent rain may have allowed sufficient time for the sheathing to dry. Owner disclosure is recommended and/or invasive inspection by a licensed roofing contractor to ensure the weathertightness of the roof shingles.

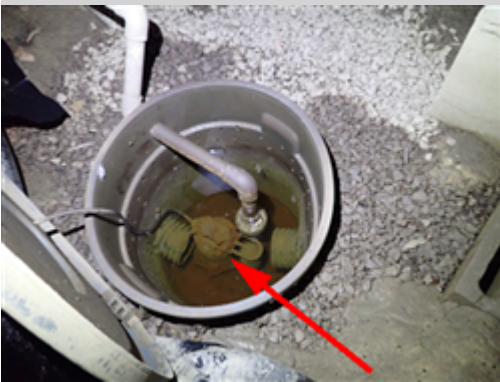
A sump pump have been installed in the crawl space to control direct water penetration. At the time of the inspection, the sump basin was full of water indicating that the sump pump system was not functioning. Standing water in the crawl space can result in elevated moisture levels, damage to the foundation and undesirable conditions. A licensed general contractor with experience in crawl space drainage should be consulted for a complete evaluation of the foundation drainage and to make necessary repairs to ensure that crawl space drainage and or moisture issues are corrected.

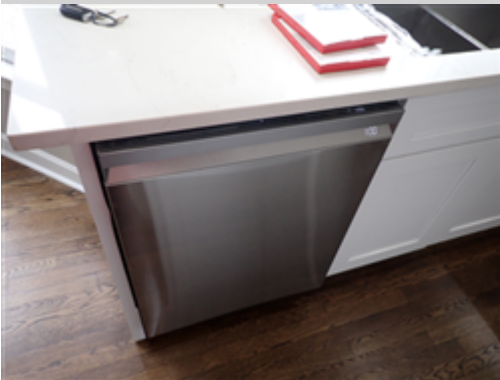
The dishwasher did not fill when requested to operate through the normal cycle. The dishwasher and the related plumbing systems need further evaluation and repair to ensure sanitary and proper operation. An appliance repair specialist should be consulted.

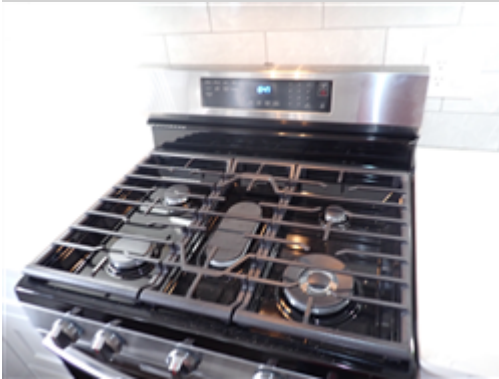
The burners for the gas range failed to turn on. Further evaluation is needed to determine the significance of this concern. A qualified technician should be consulted for evaluation and repair as needed.

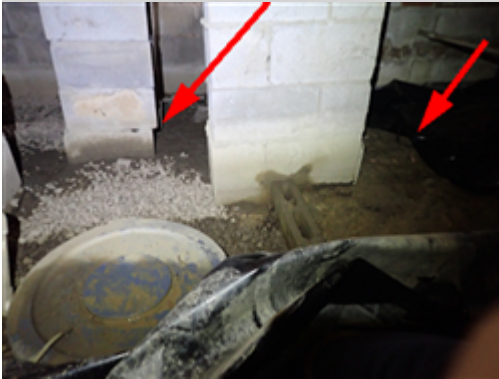
In the crawl space, the foundation walls under the front porch area was wet and the soil adjacent to the foundation was muddy from direct water penetration. Direct water penetration damages the foundation, the wood structure, and creates an undesirable environment in the crawl space areas that encourages insects and or fungal growths such as mold/mildew. Water in the crawl space indicates an absent or damaged waterproofing and foundation drain system. Repairs are needed to prevent water penetration. A licensed general contractor should be consulted for further evaluation to determine the source of the moisture and to make necessary repairs.

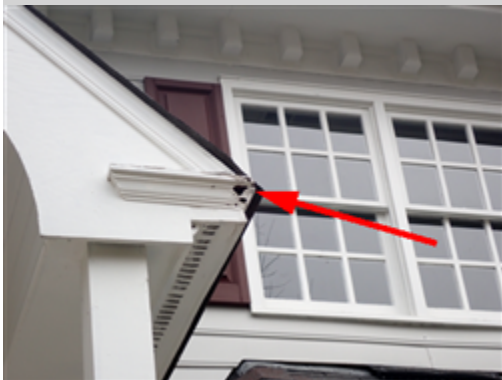
The wood trim pieces for the siding system are decayed at several corner locations. The corner trim provides a finished edge for siding and protects the underlying sheathing. Decay of the corner trim can allow water to enter behind the siding and result in damage to the framing. A licensed general contractor should be consulted for an invasive inspection to determine the extent of the damage to underlying components and make necessary repairs to ensure the weathertightness of the cladding system.

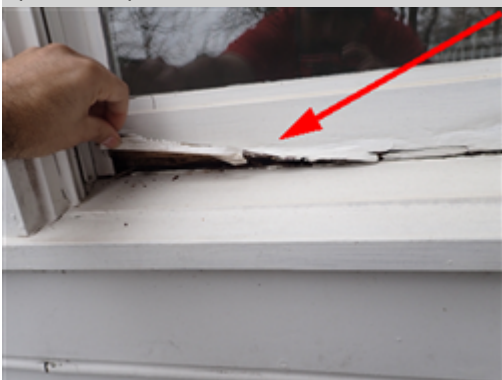
Several windows around the home have soft and decayed wood in the sill, trim, and/or sash area. Decay in the windows can result in leaking and water penetration and should be repaired as soon as possible. All windows should be inspected for similar damage as repairs are made. A licensed general contractor should be consulted to evaluate the extent of the damage and make necessary repairs.

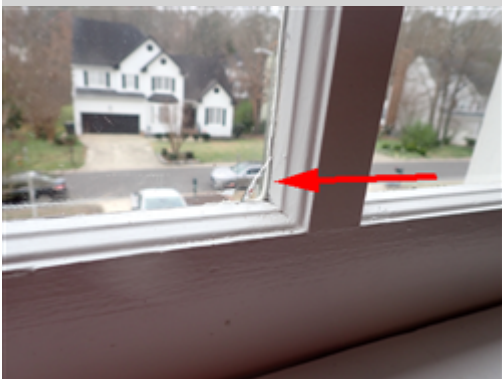
The glass windows in the home are single pane glass typical for the era of the home. A few panes throughout the home were noted to be cracked. Single pane windows are easily broken and can result in serious injury for children. A window restoration specialist or licensed general contractor should be consulted to determine the extent of the damage and make necessary repairs.

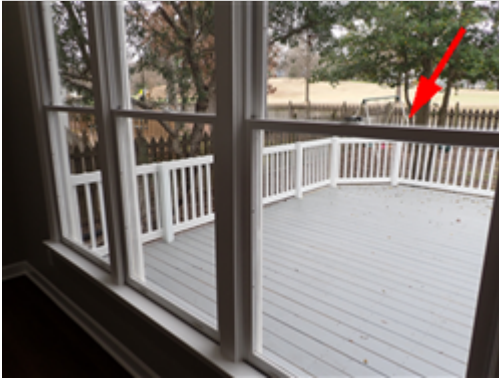
A rear living room window will not remain in the open position and may drop suddenly when opened. Repair is needed to ensure proper function of the window. A licensed general contractor should be consulted for evaluation and repair.

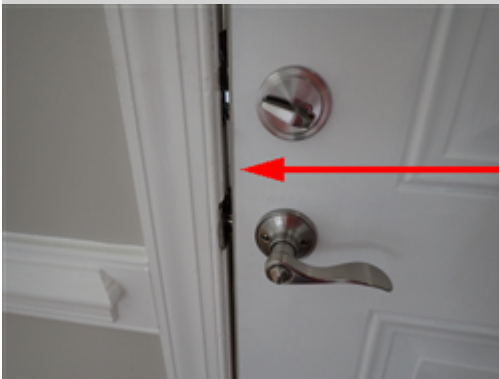
The front entry door reveals daylight at the door frame when latched. This can cause some heat loss in the winter and loss of cool air in the summer if not corrected. A qualified person should repair or replace as needed.

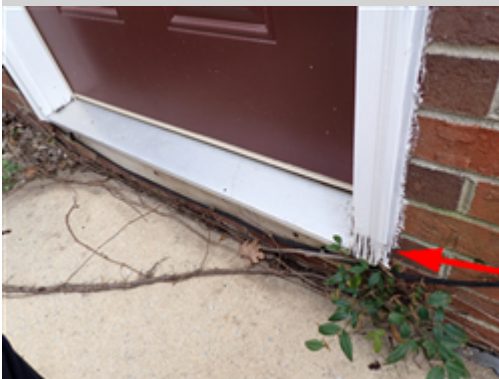
The left exterior door (Garage area) has soft and decayed wood in the frame area. Decay in the door frames can result in leaking and water penetration and should be repaired as soon as possible. A general repair specialist or licensed general contractor should be consulted for evaluation and repair.

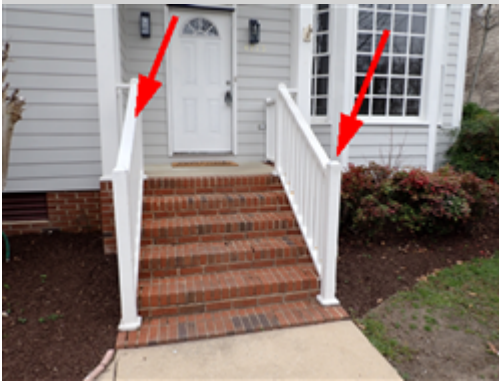
The guardrails to the front porch steps were loose and present a safety/fall hazard. Repair is needed to prevent further damage. A licensed general contractor should be consulted for evaluation of the deck handrail system and to make necessary repairs.

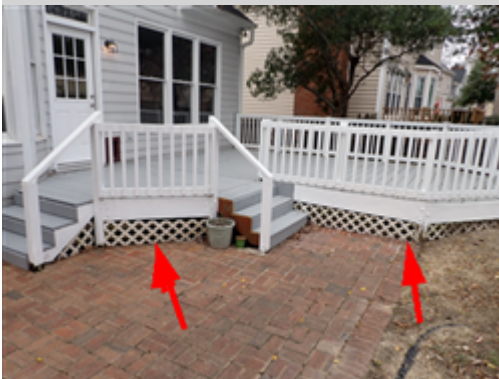
The area under the rear deck was not accessible for inspection. Its recommended to create an access point and have the area properly inspected prior to closing to ensure safe use of the deck area.

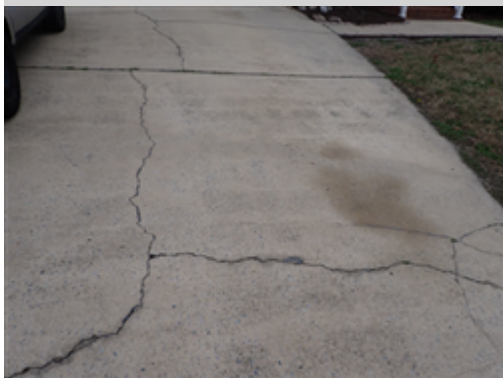
The driveway is cracked and displaced. The raised section of the driveway has created a path for water penetration under the slab and a trip or fall hazard. A licensed general contractor should be consulted for further evaluation and repair.

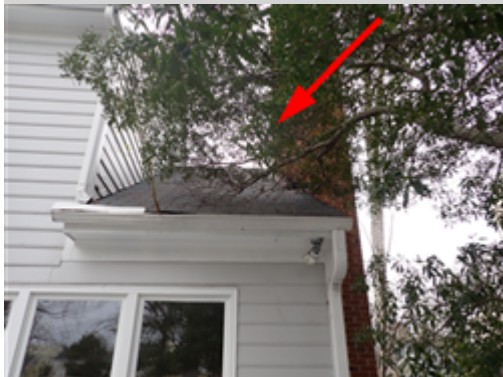
Tree limbs may decrease the life-span of siding and roof material. The tree limbs that are in contact with/near the roof and eaves areas around the home should be trimmed. A qualified person should be consulted for evaluation and repair.

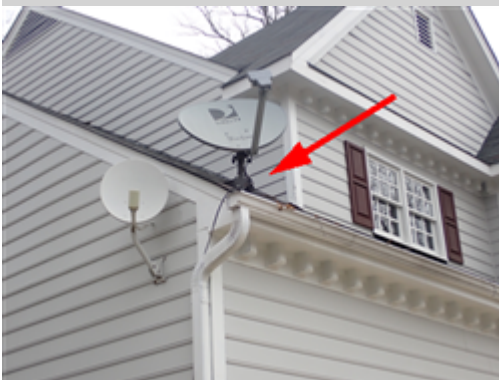
Installation of TV satellite receivers is not recommended on the roof. The installation requires for the roof shingles to be damaged. Further evaluation is needed to determine the significance of this concern. A licensed roofing contractor should be consulted for evaluation and repair as needed to ensure the weathertightness of the roof.

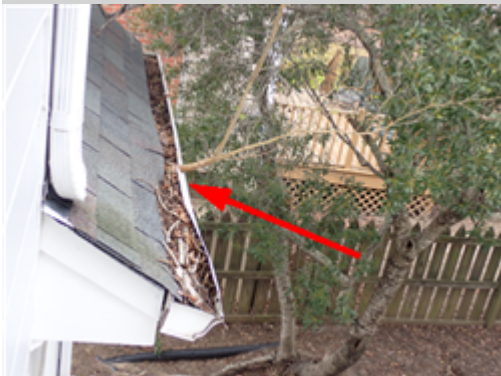
The gutters were full of debris in some areas, and need to be cleaned. Debris in gutters can conceal rust, deterioration, or leaks that are not visible until cleaned, and I am unable to determine if such conditions exist.

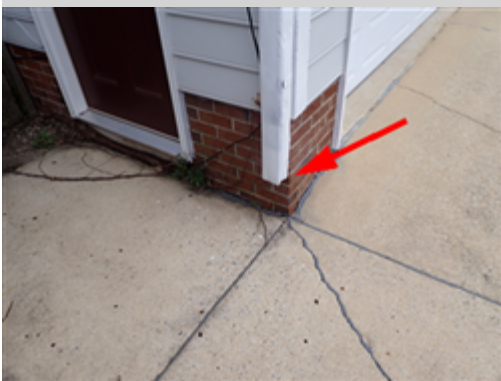
The front left downspout needs an extension to carry water away from the foundation of the home. The current configuration has the downspouts draining into the foundation of the home. A licensed, general contractor should be consulted for evaluation and repair.

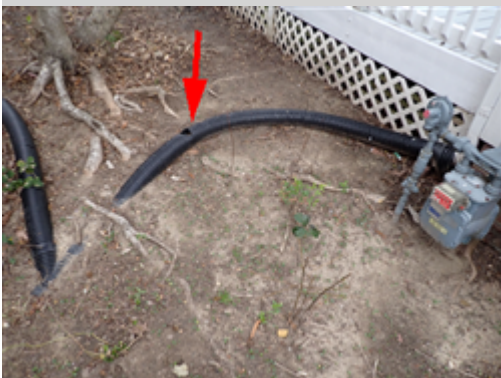
Several gutter downspouts were piped underground and had visible damaged . Some of the downspouts exits were not located or verified. Evidence in the bedding area and at the roof eave level suggests that the gutters have been overflowing. Direct drainage to the foundation and cladding from the gutter system can result in water penetration into the foundation area and foundation deterioration. A licensed general contractor should be consulted for a complete evaluation to locate and verify the downspout extension and to make necessary repairs.

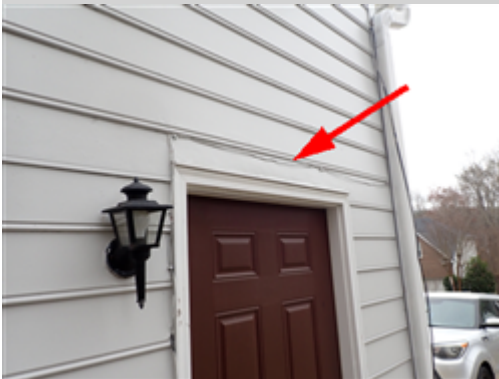
At the time of the inspection, the exterior windows and doors appeared to have no flashing installed above the opening and were dependent upon sealant to prevent moisture intrusion. Because sealants will eventually dry, shrink and crack, leaving the home exposed to possible moisture intrusion, sealant-dependent areas should be examined on an annual basis and sealant re-applied as necessary. Further evaluation is needed to determine the significance of this concern. A licensed general contractor should be consulted for evaluation and repair as needed to ensure the weathertightness of the cladding system.
