## Property Inspection Report

**Report Number: 20230301JF1**

123 Main St.  
Raleigh, North Carolina 27604

**Date of Inspection: Wednesday, March 1, 2023**

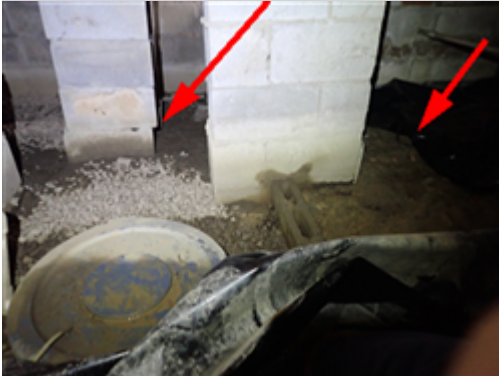
##### (A1 - 1.1) Main House

In the crawl space, the foundation walls under the front porch area was wet and the soil adjacent to the foundation was muddy from direct water penetration. Direct water penetration damages the foundation, the wood structure, and creates an undesirable environment in the crawl space areas that encourages insects and or fungal growths such as mold/mildew. Water in the crawl space indicates an absent or damaged waterproofing and foundation drain system. Repairs are needed to prevent water penetration. A licensed general contractor should be consulted for further evaluation to determine the source of the moisture and to make necessary repairs.

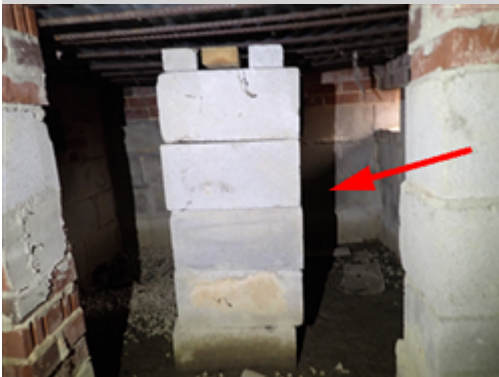
##### (A2 - 1.1) Main House

The "Dry Stacked" columns located under the front porch were not securely fastened at the top or bottom of the columns. Lateral bracing or fastening of the column base reduces the probability of column movement when impacted or exposed to loading. A licensed general contractor should be consulted for further evaluation and to make necessary repairs.

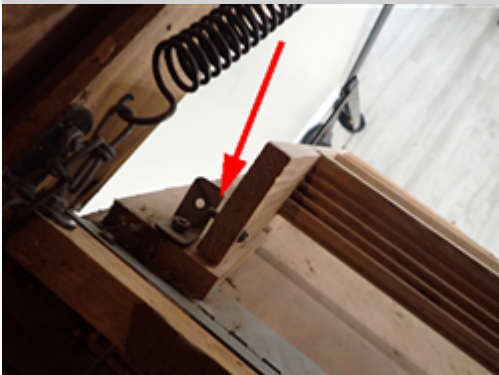
##### (A5 - 1.1) Attic

The attic ladder was found to be in poor condition; a top screw was disconnected. The ladder needs repair to prevent a safety or fall hazard. A licensed general contractor should be consulted for a complete evaluation and make necessary repairs.

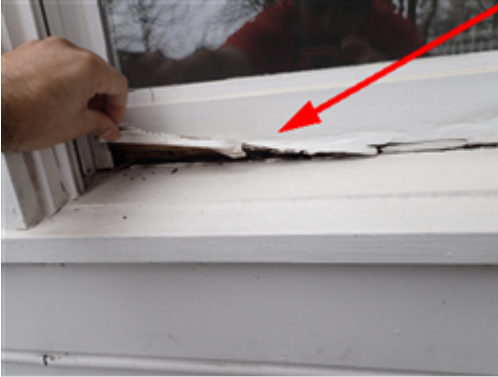
**(B2 - 1.1 ) Windows**

Several windows around the home have soft and decayed wood in the sill, trim, and/or sash area. Decay in the windows can result in leaking and water penetration and should be repaired as soon as possible. All windows should be inspected for similar damage as repairs are made. A licensed general contractor should be consulted to evaluate the extent of the damage and make necessary repairs.

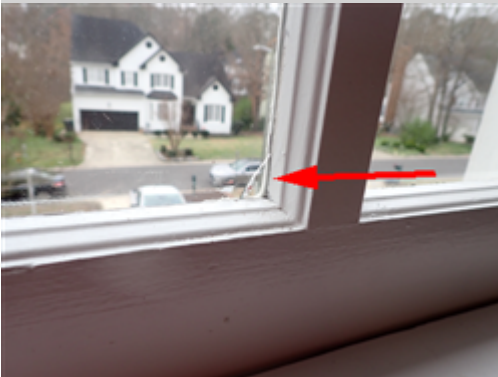
**(B2 - 1.2 ) Windows**

The glass windows in the home are single pane glass typical for the era of the home. A few panes throughout the home were noted to be cracked. Single pane windows are easily broken and can result in serious injury for children. A window restoration specialist or licensed general contractor should be consulted to determine the extent of the damage and make necessary repairs.

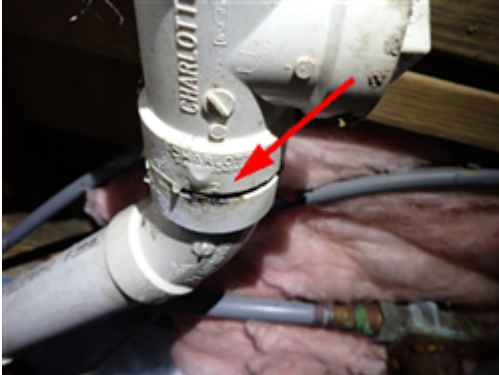
#### (D2 - 1.1 ) All Accessible Areas

The main waste line is leaking under the first floor half bathroom area in the crawlspace. The waste line needs to be repaired to ensure sanitary conditions. A licensed plumbing contractor should be consulted for complete evaluation and of the waste line systems to determine the general condition of the system and to make necessary repairs.

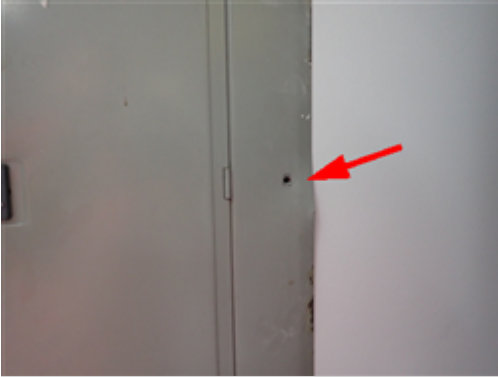
#### (E2 - 1.2 ) Main Panel

The main electrical service panel cover is missing fasteners that secure the cover to the enclosure. The door/cover prevents direct contact with hot electrical circuits and contains the electrical energy of the electrical system in the event of a short or electrical explosion; therefore the cover must be secured with the correct type, size and number of fasteners. This condition presents a safety hazard that could result in serious personal injury or death. A licensed electrical contractor should be consulted for a complete inspection of the electrical system and for repair/replacement of the panel to ensure that it is safe and functioning properly.

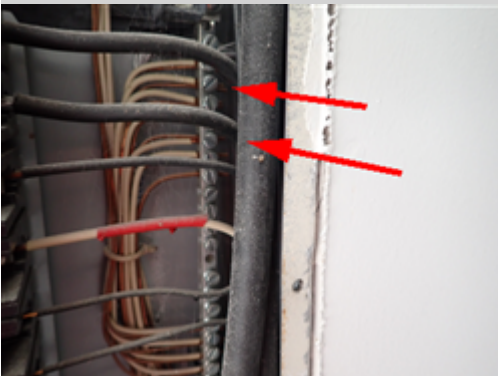
#### (E2 - 1.4 ) Main Panel

The ground/neutral bus bar for the main electrical panel has several double taps where two neutral conductors are connected together under one screw. This condition presents a safety hazard that could result in interrupted service, property damage, and serious personal injury. A licensed electrical contractor should be consulted for a complete evaluation and to make necessary repairs.

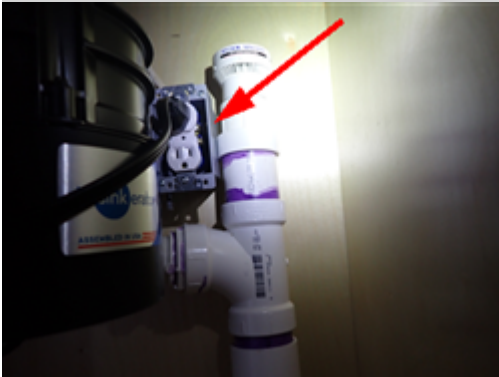
##### **(E5 - 1.1 ) Main House**

The receptacles under the kitchen sink and garage area were missing the cover faceplate. A missing receptacle cover could result in increased shock and fire hazards. A licensed electrical contractor should be consulted to make necessary repairs to ensure safe and proper operation and installation.

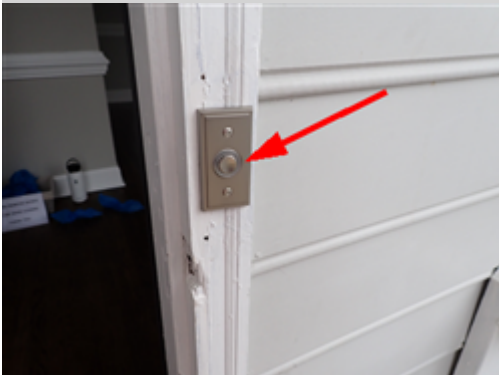
##### **(E5 - 2.2 ) Exterior**

The doorbell as tested from the main entrance and found not to be functional. A general repair specialist should be consulted for evaluation and repair.

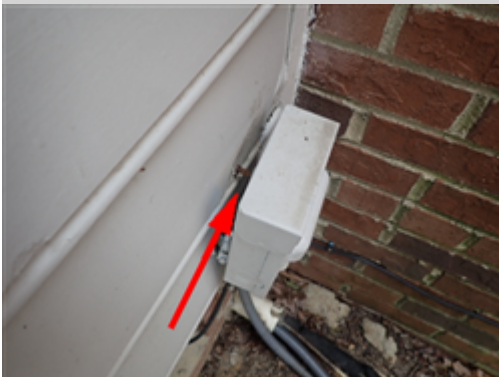
#### **(G1 - 2.4 ) Cooling Unit #2**

The electrical turn off for the exterior HVAC unit is not secure where it is attached to the wall of the home. This condition presents a safety hazard that could result in serious personal injury and or property damage. The electrical panel cover was not removed and the inspection was not completed. A licensed electrical contractor should be consulted for a complete inspection of the electrical system and for repair/replacement of the panel to ensure that it is safe and functioning properly.

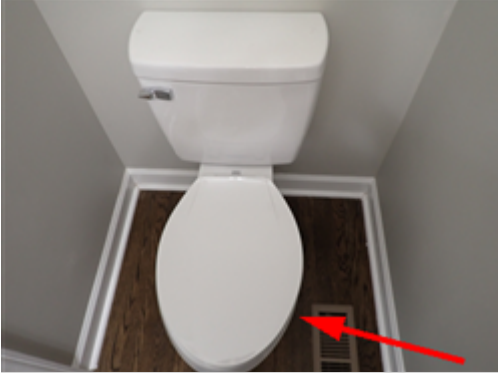
##### **(H3 - 1.1 ) First floor half bathroom**

The first floor half bathroom toilet was not secured tightly to the floor. Movement of the toilet can result in leaks and damage. A licensed plumbing and general contractor should be consulted for evaluation and repair.

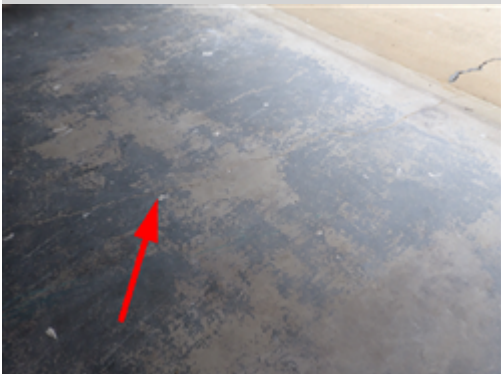
#### (H4 - 1.2 ) Garage

The garage floor has several cracks that may need to be sealed to prevent further damage. The crack may be caused by settlement. The buyer should review the area of concern. If additional concerns or questions are present, an invasive inspection and repair will be needed by a structural engineer.

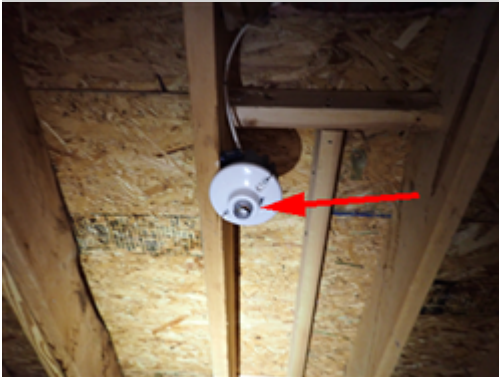
##### **(H5 - 1.1 ) Attic: Unfinished**

The rear left attic light fixture was not tested because the bulbs have been broken off in the sockets. This presents a hazardous condition. The broken bulb socket need to be removed and the fixture verified to operate properly. A general repair specialist should be consulted.

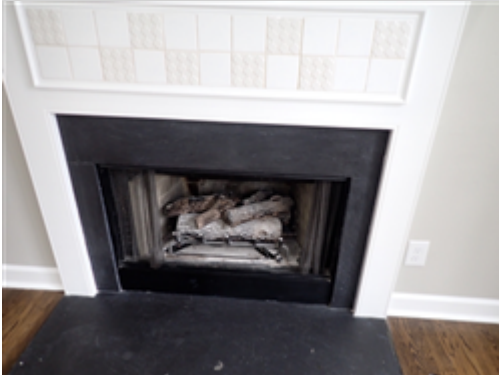
##### **(H6 - 1.1 ) Fireplace: Pre-Manufactured: Metal: Box: Sided Exterior**

The gas log unit was visually inspected but not operated because the pilot was off. The unit should be serviced and operated prior to closing to ensure safe and proper operation of the HVAC system.

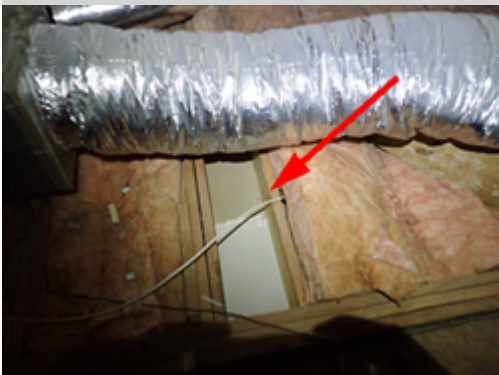
##### **(I1 - 1.1 ) Attic: Main House**

A section of insulation in the attic is missing. Improper insulation installation could result in condensation, over heating of the building components, and inadequate conditioning of the living areas. A licensed general contractor should be consulted for repair/replacement.

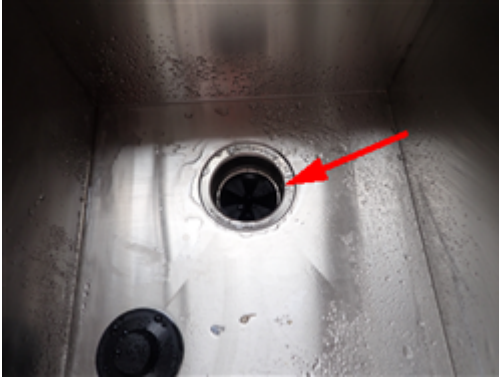
**(J1 - 2.1 ) Garbage Disposal**

The disposal was loud and vibrated when operated. Appliances should be repaired and inspected prior to purchase to ensure safe and proper operation. An appliance repair specialist should be consulted for full evaluation and repair.

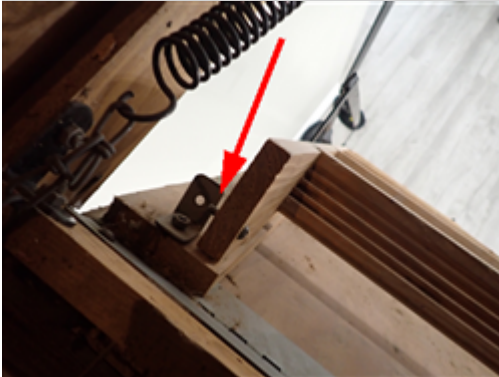
**(A5 - 1.1 ) Attic**

The attic ladder was found to be in poor condition; a top screw was disconnected. The ladder needs repair to prevent a safety or fall hazard. A licensed general contractor should be consulted for a complete evaluation and make necessary repairs.

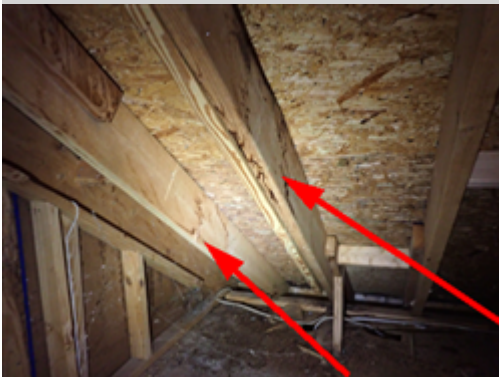
**(A6 - 1.1 ) Main House**

In the attic, the roof sheathing above the living room and dinning room had areas of discoloration that appeared to be the result of roof leakage. Moisture meter testing showed no elevated moisture levels in affected areas at the time of the inspection. Either the source of the leak has been corrected, or the lack of recent rain may has allowed sufficient time for the sheathing to dry. Owner disclosure is recommended and/or invasive inspection by a licensed roofing contractor to ensure the weathertightness of the roof shingles.

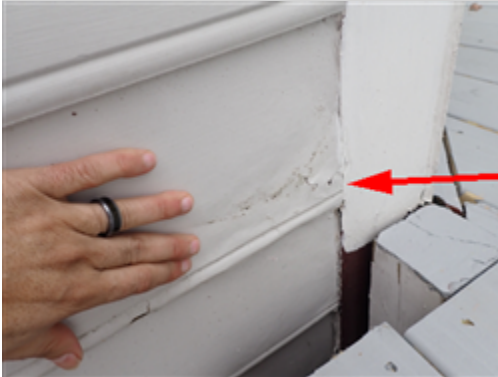
**(B1 - 1.1) Main House**

This home has Hardboard Siding. Many homes built between 1970 and the 1990's were sided with this composite type siding. Over the years there have been class actions lawsuits related to claims of improperly manufactured siding and problems with decay. The problems were accelerated due to the limited life expectancy of this siding material; most products were warrantied only for 20 to 25 years. Hardboard siding naturally absorbs water when not protected and improper maintenance can result in siding decay and hidden damage. With proper sealant application and regular paint maintenance, this process can be controlled and kept at a safe level for many homes. However, improperly manufactured, maintained, and or installed hardboard siding can undergo serious deterioration that can result in the need to replace the siding as well require repairs to the underlying structure. The siding for this home was found to be in fair condition. Siding boards were noted to have swollen edges, swollen nail spots, and decay in adjacent trim pieces around the perimeter of the home. The visible exterior decay could also indicate damage to the substrate and underlying framing. A licensed general contractor should be consulted for a complete evaluation to determine the extent of the damage to the siding, trim, and underlying components and to make necessary repairs.

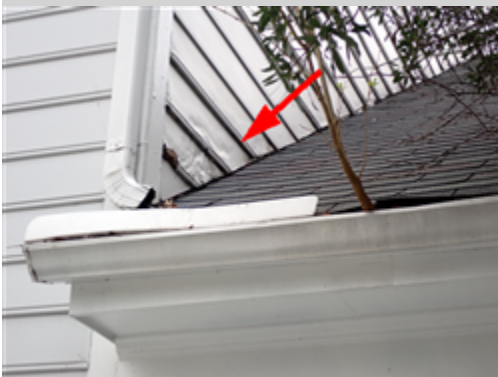
**(B1 - 1.2) Main House**

Additional Photograph: This is a photograph of rear siding damage.

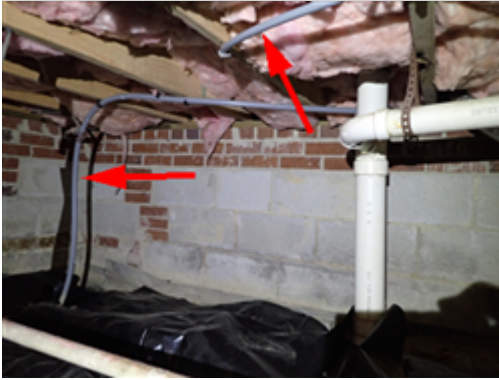
**(D1 - 1.2 ) All Accessible Areas**

This home has a plumbing supply system that uses polybutylene plastic distribution lines and compression band fittings. Even though this plumbing system was installed in many homes from 1978 until mid-1990's, it is no longer manufactured in the original formulation as an approved plumbing system due to a history of material failures. The failures were related to improper installation, improper handling, improper storage, and plastic deterioration due to chemical reactions with the water supply. Due to the nature of this latent defect, it was not possible to adequately assess the condition of the plumbing system during the home inspection. A licensed plumbing contractor should be consulted for a complete evaluation of the plumbing system to determine the significance of this concern.

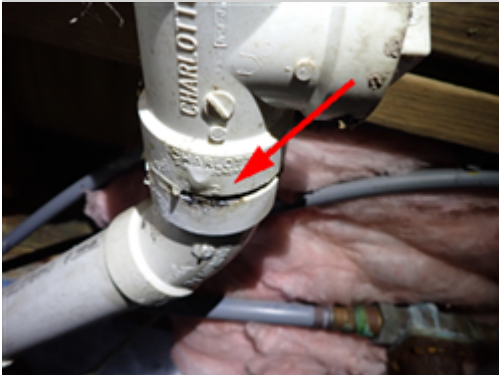
**(D2 - 1.1 ) All Accessible Areas**

The main waste line is leaking under the first floor half bathroom area in the crawlspace. The waste line needs to be repaired to ensure sanitary conditions. A licensed plumbing contractor should be consulted for complete evaluation and of the waste line systems to determine the general condition of the system and to make necessary repairs.

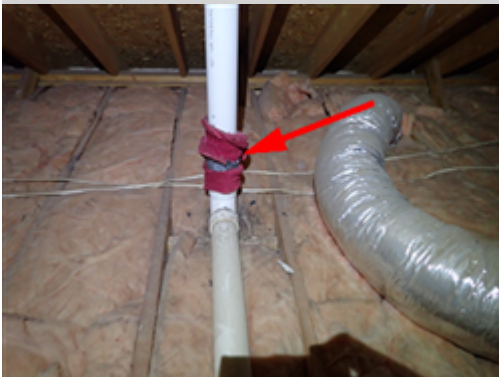
**(D2 - 1.2 ) All Accessible Areas**

A main vent for the plumbing system has been repaired in the attic. The repair does not comply with typical contractor repair. The upper section of the pipe acts as a vent for waste gases, the lower section of the pipe that carries waste water to the main system. If the main pipe is not installed properly the sewer gases can enter the home or water intrusion, from rain, may happen. A licensed plumbing contractor should be consulted for a complete evaluation to determine the significance of this concern and to make necessary repairs.

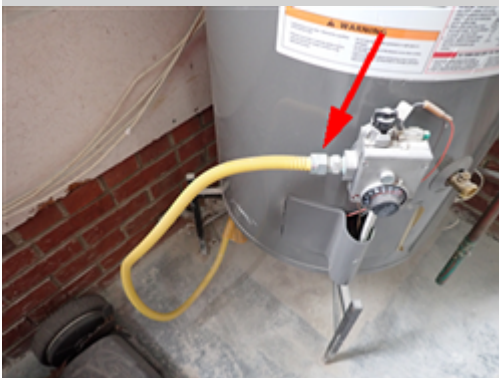
### (D3 - 1.3 ) Water Heater

The gas line for the water heater was not installed with a sediment trap in the line to prevent debris from entering the gas valve. This creates a safety issue that could result in personal injury or property damage if not corrected. A HVAC or plumbing contractor should be consulted for further evaluation and repair.

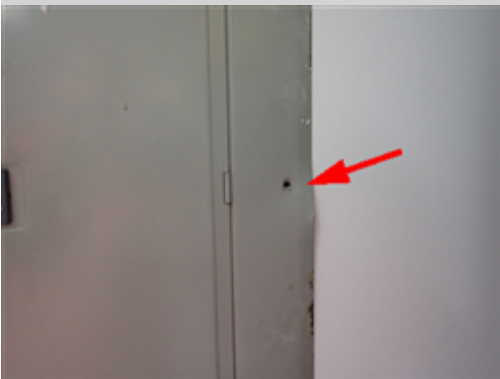
#### (E2 - 1.2 ) Main Panel

The main electrical service panel cover is missing fasteners that secure the cover to the enclosure. The door/cover prevents direct contact with hot electrical circuits and contains the electrical energy of the electrical system in the event of a short or electrical explosion; therefore the cover must be secured with the correct type, size and number of fasteners. This condition presents a safety hazard that could result in serious personal injury or death. A licensed electrical contractor should be consulted for a complete inspection of the electrical system and for repair/replacement of the panel to ensure that it is safe and functioning properly.

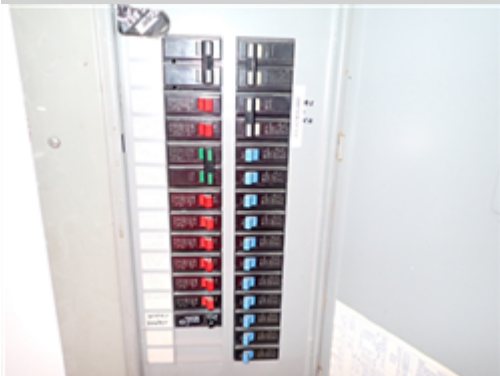
#### (E2 - 1.3 ) Main Panel

The service breakers in the panel are not properly identified or labeled. Proper labeling ensures adequate service for appliances and sub-panels and the overall safety of system when emergencies occur or repairs are needed. Without proper labels the inspector's ability to evaluate and inspect the system is greatly reduced. A licensed electrical contractor should be consulted for a complete evaluation to label all electrical panels, subpanels, and service breakers and verify the compatibility of the configuration, and the main service disconnect.

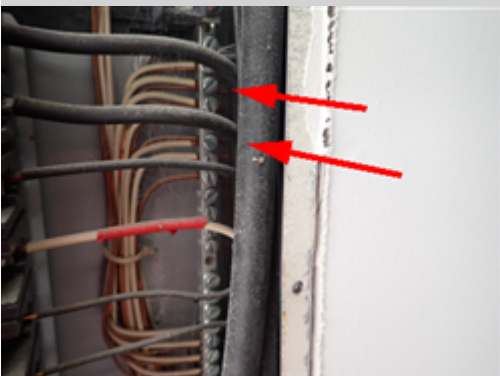
#### (E2 - 1.4 ) Main Panel

The ground/neutral bus bar for the main electrical panel has several double taps where two neutral conductors are connected together under one screw. This condition presents a safety hazard that could result in interrupted service, property damage, and serious personal injury. A licensed electrical contractor should be consulted for a complete evaluation and to make necessary repairs.

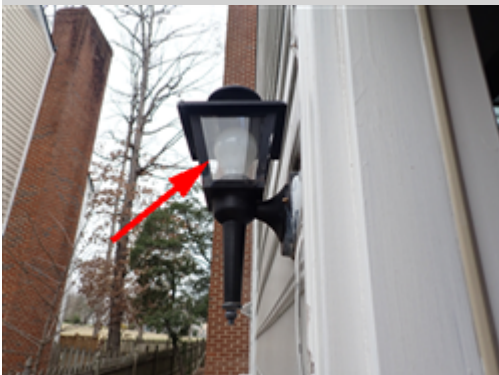
**(E5 - 2.1 ) Exterior**

The left exterior light fixture was not functional when tested. This could indicate a defective bulb or other more serious problem such as faulty wiring or a defective fixture. A licensed electrical contractor should be consulted for further evaluation and repair.

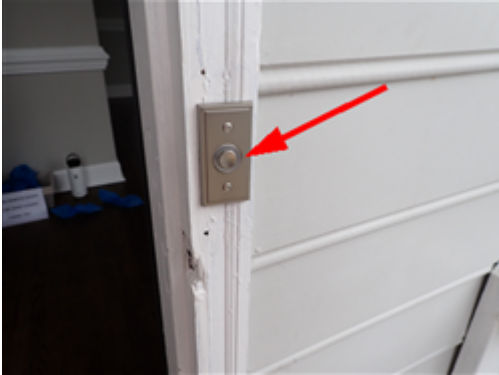
## (E5 - 2.2 ) Exterior

The doorbell as tested from the main entrance and found not to be functional. A general repair specialist should be consulted for evaluation and repair.

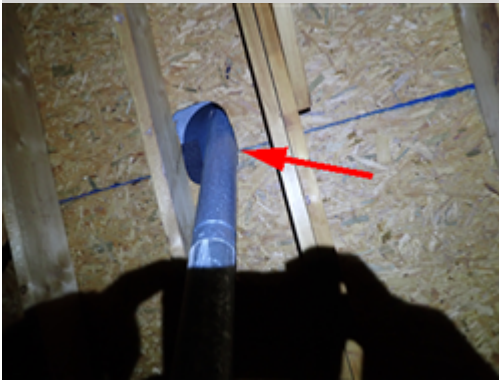
**(F1 - 2.3 ) Heating Unit (Second floor unit)**

The attic furnace flue was in contact with the wood roof sheathing. Per installation instructions the flue should have a one inch clearance from combustible. This condition creates a fire hazard in need of repair as soon as possible. A licensed HVAC contractor should be consulted for further evaluation and repair as needed to ensure safe and reliable service of the HVAC unit.

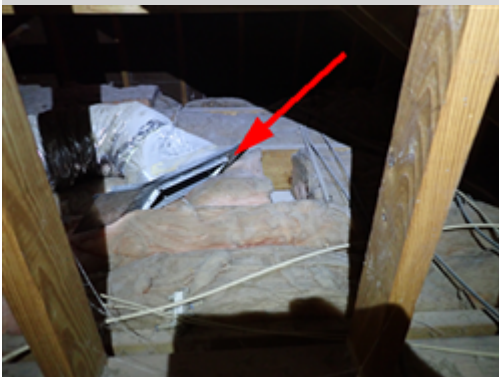
**(F2 - 2.1 ) Heating Unit #2**

An attic duct above the second floor hallway bathroom was disconnected and in need of repair/replacement. An HVAC contractor should be consulted for a complete evaluation and repair of the duct system to ensure reliable and proper operation of the HVAC system.

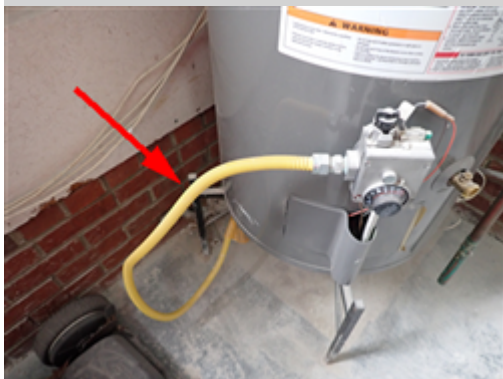
**(F3 - 2.1 ) Garage**

This home has corrugated stainless steel gas lines. This gas line has specific installation requirements related to required bending allowances, support, protection, and electrical bonding to ensure safe conditions. The electrical bonding is typically required to prevent damage from electrical storms in the event of a lightning strike. During the home inspection the bonding attachment could not be located. An electrical contractor should be consulted for a complete evaluation of the CSST installation and to verify the presence of electrical bonding.

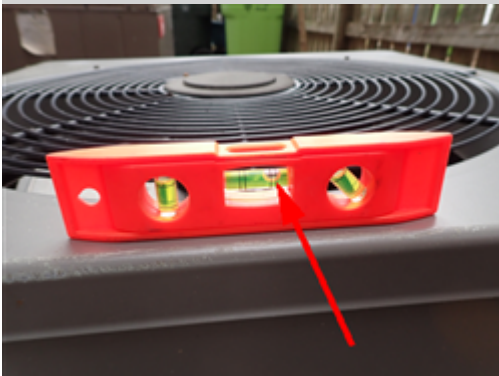
### (G1 - 2.3 ) Cooling Unit #2

The outside compressor/coil unit for the AC system is not level. The system should be level to ensure proper and reliable operation of the system. A HVAC contractor should be consulted for a complete evaluation and repair of the system to ensure reliable and proper operation of the HVAC system.

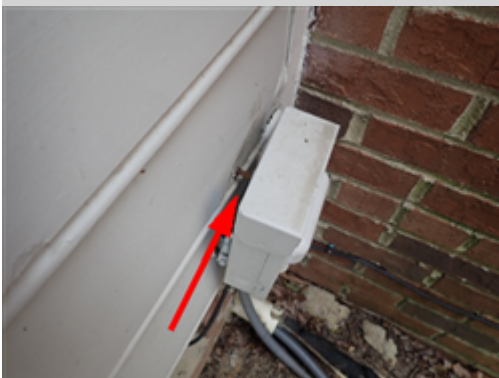
### (G1 - 2.4 ) Cooling Unit #2

The electrical turn off for the exterior HVAC unit is not secure where it is attached to the wall of the home. This condition presents a safety hazard that could result in serious personal injury and or property damage. The electrical panel cover was not removed and the inspection was not completed. A licensed electrical contractor should be consulted for a complete inspection of the electrical system and for repair/replacement of the panel to ensure that it is safe and functioning properly.

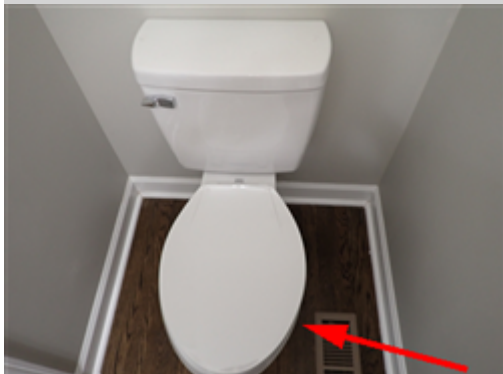
##### (H3 - 1.1 ) First floor half bathroom

The first floor half bathroom toilet was not secured tightly to the floor. Movement of the toilet can result in leaks and damage. A licensed plumbing and general contractor should be consulted for evaluation and repair.

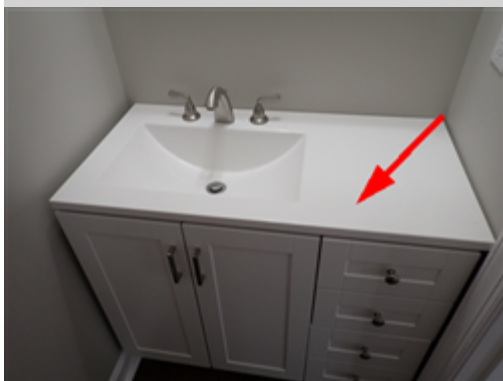
##### (H3 - 1.2 ) First floor half bathroom

The first floor half bathroom sink counter top was loose. repair is needed to prevent further damage. A licensed general contractor should be consulted for evaluation and repair as needed.

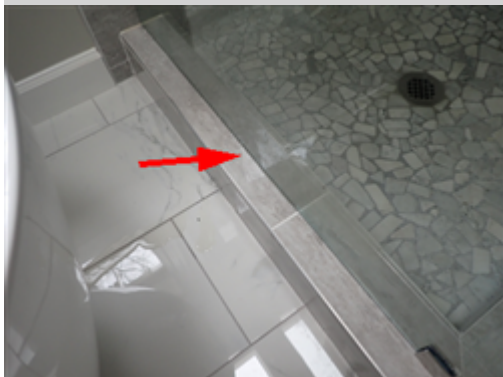
##### (H3 - 2.1 ) Second floor master bathroom

The master bathroom shower wall was missing caulking at the bottom of the wall where it meets the floor. The area leaks when the shower is in use. Repair is needed to ensure proper operation of the shower. A licensed general contractor should repair as needed.

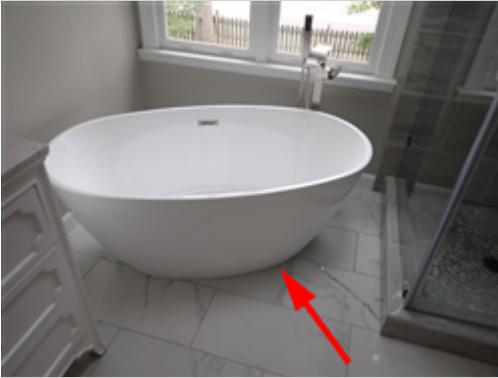
### (H3 - 2.2 ) Second floor master bathroom

The master bathroom tub was loose. Repair is needed to prevent further damage. A licensed general contractor should repair as needed to ensure proper operation of the tub.

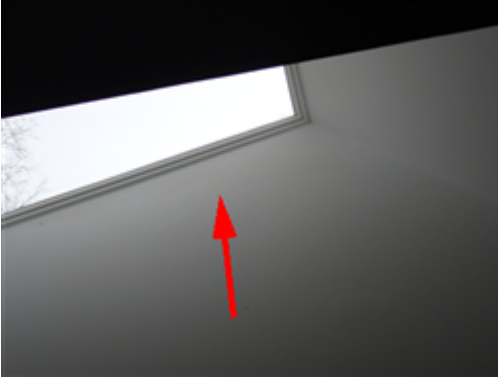
### (H3 - 2.3 ) Second floor master bathroom

Skylights have a high probability of leaking due to high drainage exposure at their intersection with the roof line and need to be inspected and maintained annually. At the time of the inspection stains were noticed around the master bathroom skylight area. A licensed roofing contractor should be consulted to evaluate the installation, and flashing of the skylight.

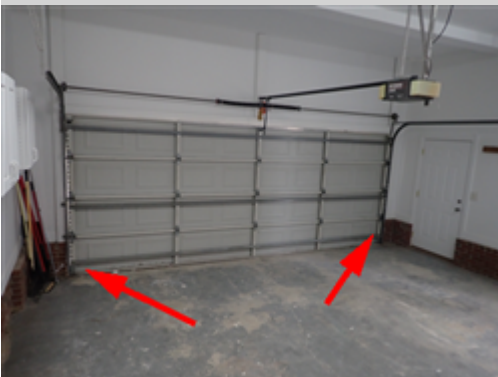
#### (H4 - 1.1 ) Garage

The garage door needs adjustment and repair. The electronic eyes were not present at the time of the inspection. A garage door installation company or a licensed general contractor should be consulted for evaluation and repair to ensure that the door operates safely and properly.

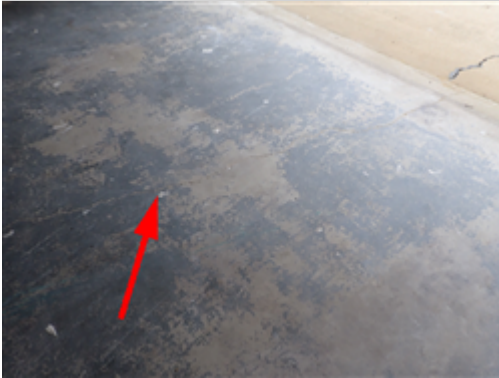
#### (H4 - 1.2 ) Garage

The garage floor has several cracks that may need to be sealed to prevent further damage. The crack may be caused by settlement. The buyer should review the area of concern. If additional concerns or questions are present, an invasive inspection and repair will be needed by a structural engineer.

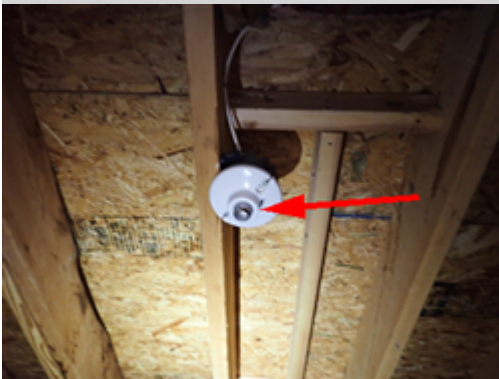
##### (H5 - 1.1 ) Attic: Unfinished

The rear left attic light fixture was not tested because the bulbs have been broken off in the sockets. This presents a hazardous condition. The broken bulb socket needs to be removed and the fixture verified to operate properly. A general repair specialist should be consulted.

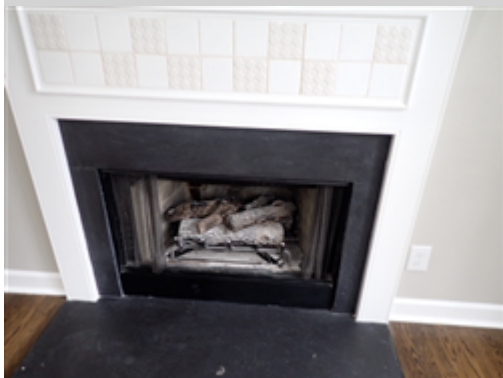
**(H6 - 1.1 ) Fireplace: Pre-Manufactured: Metal: Box: Sided Exterior**

The gas log unit was visually inspected but not operated because the pilot was off. The unit should be serviced and operated prior to closing to ensure safe and proper operation of the HVAC system.

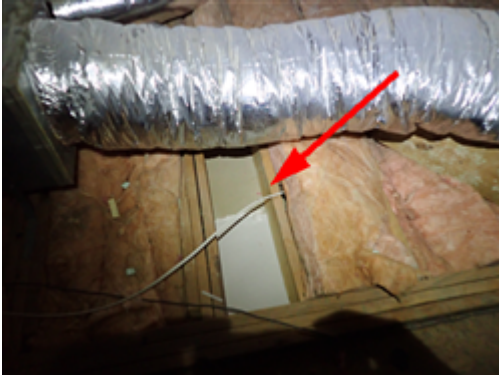
### (I1 - 1.1 ) Attic: Main House

A section of insulation in the attic is missing. Improper insulation installation could result in condensation, over heating of the building components, and inadequate conditioning of the living areas. A licensed general contractor should be consulted for repair/replacement.

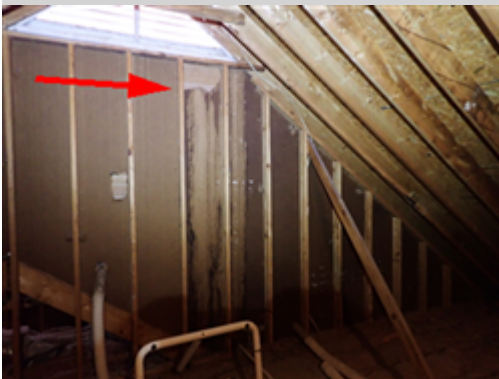
### (I1 - 1.2 ) Attic: Main House

In the attic, the interior wall had areas of discoloration and damage that appeared to be the result of water intrusion under the left gable vent area. Moisture meter testing showed no elevated moisture levels in affected areas at the time of the inspection. Either the source of the leak has been corrected, or the lack of recent rain may have allowed sufficient time for the sheathing to dry. Owner disclosure is recommended and/or invasive inspection by a licensed roofing contractor to ensure the weathertightness of the roof shingles.

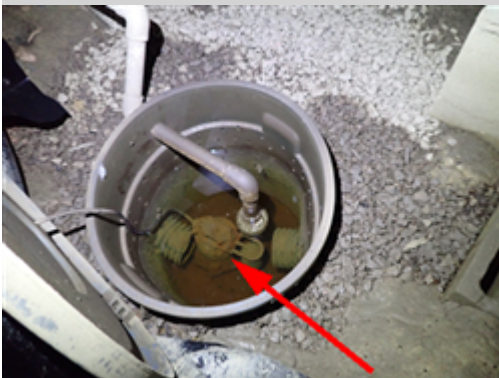
### (I1 - 2.1 ) Crawl Space

A sump pump have been installed in the crawl space to control direct water penetration. At the time of the inspection, the sump basin was full of water indicating that the sump pump system was not functioning. Standing water in the crawl space can result in elevated moisture levels, damage to the foundation and undesirable conditions. A licensed general contractor with experience in crawl space drainage should be consulted for a complete evaluation of the foundation drainage and to make necessary repairs to ensure that crawl space drainage and or moisture issues are corrected.

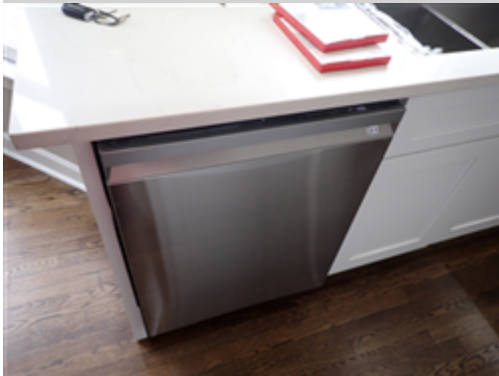
#### (J1 - 1.1 ) Dishwasher

The dishwasher did not fill when requested to operate through the normal cycle. The dishwasher and the related plumbing systems need further evaluation and repair to ensure sanitary and proper operation. An appliance repair specialist should be consulted.

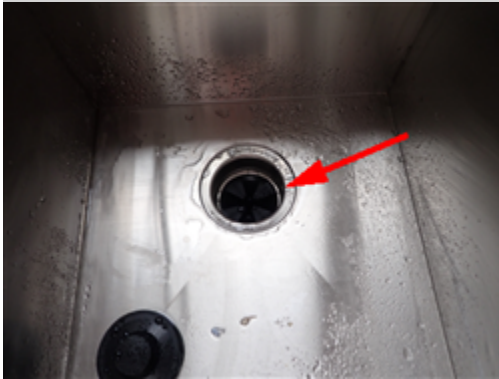
#### (J1 - 2.1 ) Garbage Disposal

The disposal was loud and vibrated when operated. Appliances should be repaired and inspected prior to purchase to ensure safe and proper operation. An appliance repair specialist should be consulted for full evaluation and repair.

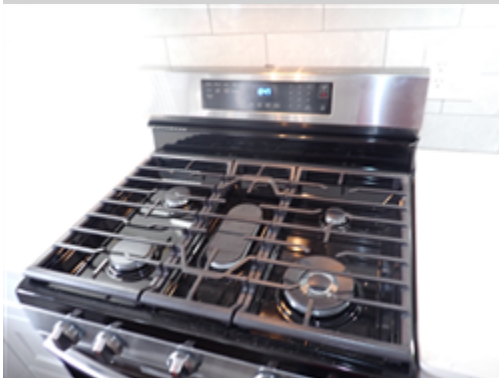
##### (J1 - 4.1 ) Range: Gas

The burners for the gas range failed to turned on. Further evaluation is needed to determine the significance of this concern. A qualified technician should be consulted for evaluation and repair as needed.
